DEVELOPMENT VARIANCE PERMIT NO. 2024-04

4. Bylaws of the District enacted under Section 479 of the *Local Government Act*, as amended from time to time, are varied or supplemented as described below.
 - (a) Zoning Bylaw No. 580, 2022 is varied for the property noted above to achieve conformance for the retaining walls shown on Attachment 2.

- i. Section 2.13.1 – to increase the maximum height of a retaining wall from 1.2 m to up to 5 m in some sections as indicated on the drawings included as Attachment 2.
- ii. Section 2.13.2 – to reduce the height ratio for a combined system of retaining walls to less than 2 horizontal to 1 vertical as indicated on the drawings included as Attachment 2.
- iii. Section 1.1.4 – to reduce the minimum setback for an accessory structure for an exterior side parcel lines from 3 m down to 0 m as indicated on the drawings included as Attachment 2.

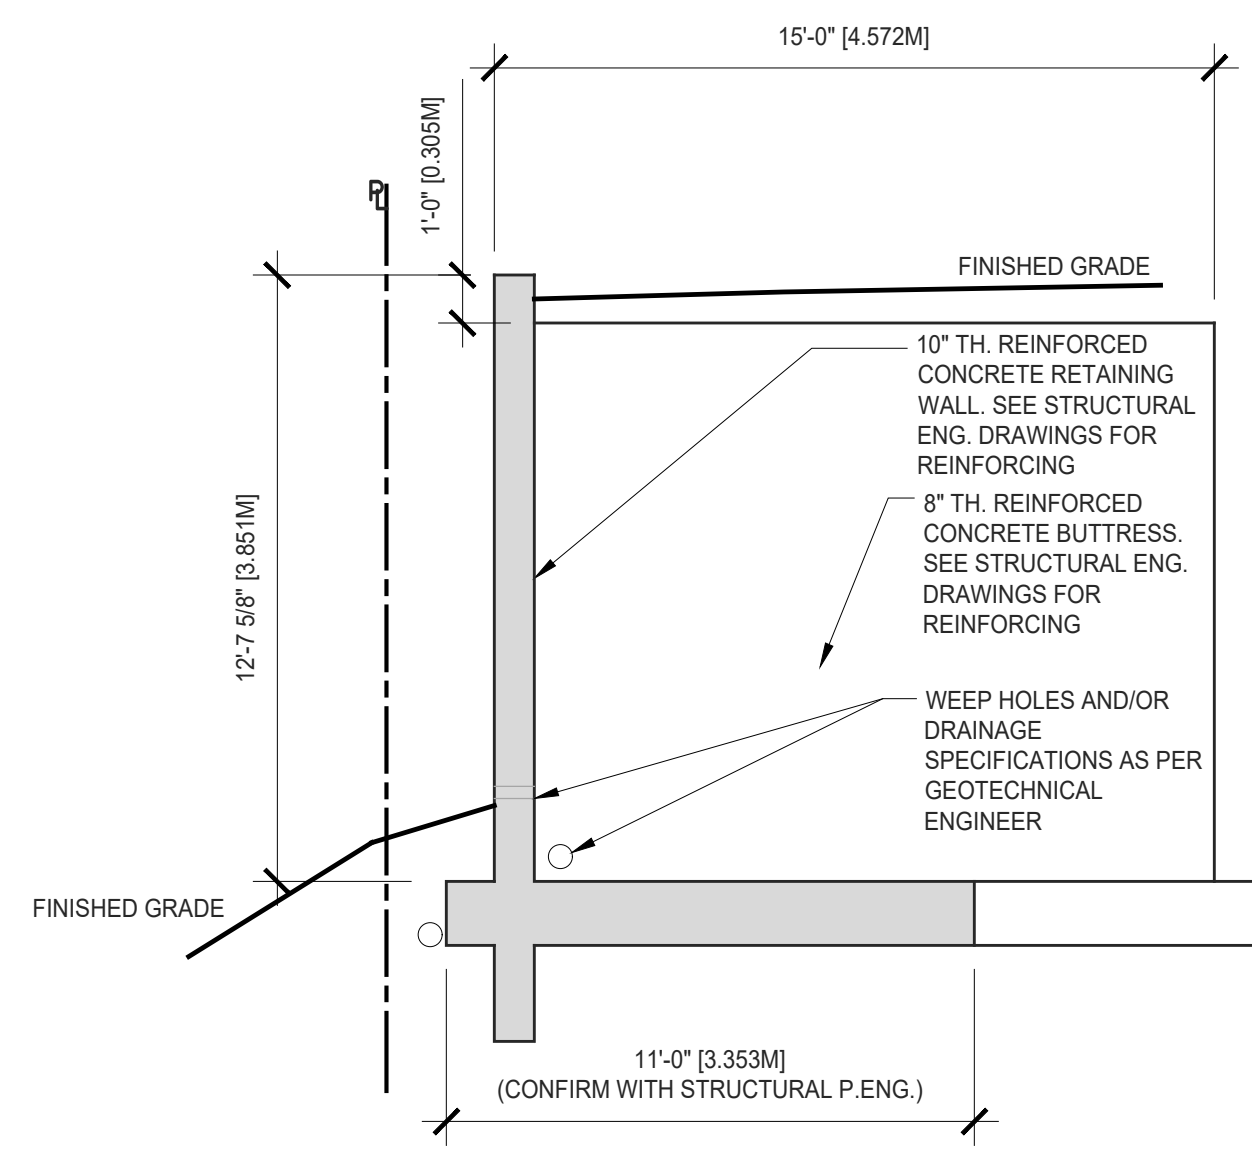
B SECTION AT LOWER BUTTRESS
SCALE: 1/4" = 1'-0"

NOTE: AREA OF EXPOSED TOP SURFACE OF RETAINING WALLS = 140.6 ft²

NOTE: FOR RETAINING WALL THICKNESSES AND STRUCTURAL DETAILS, SEE STRUCTURAL ENG. DRGS.

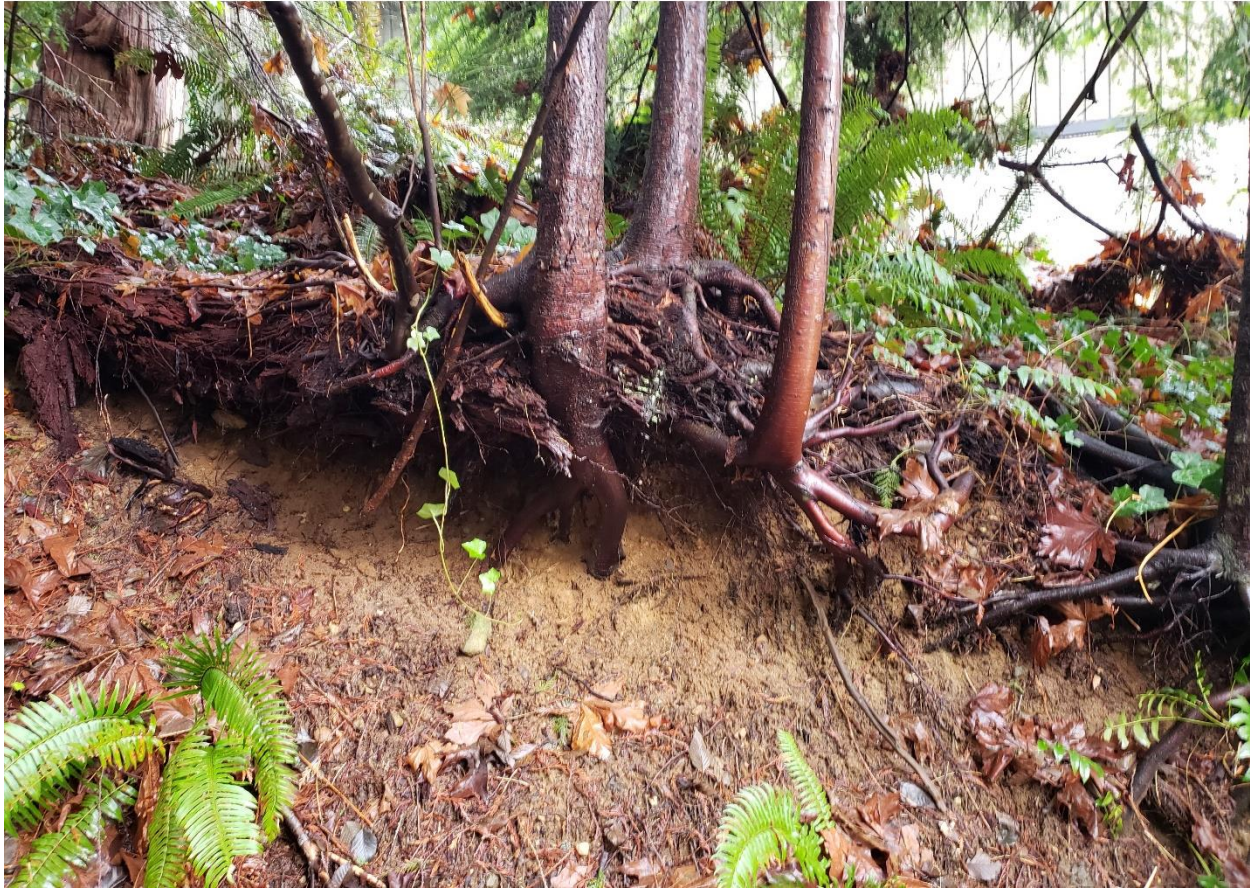
Photograph 1. Slope below bench below existing house (northwest side of lot in area of proposed retaining wall).

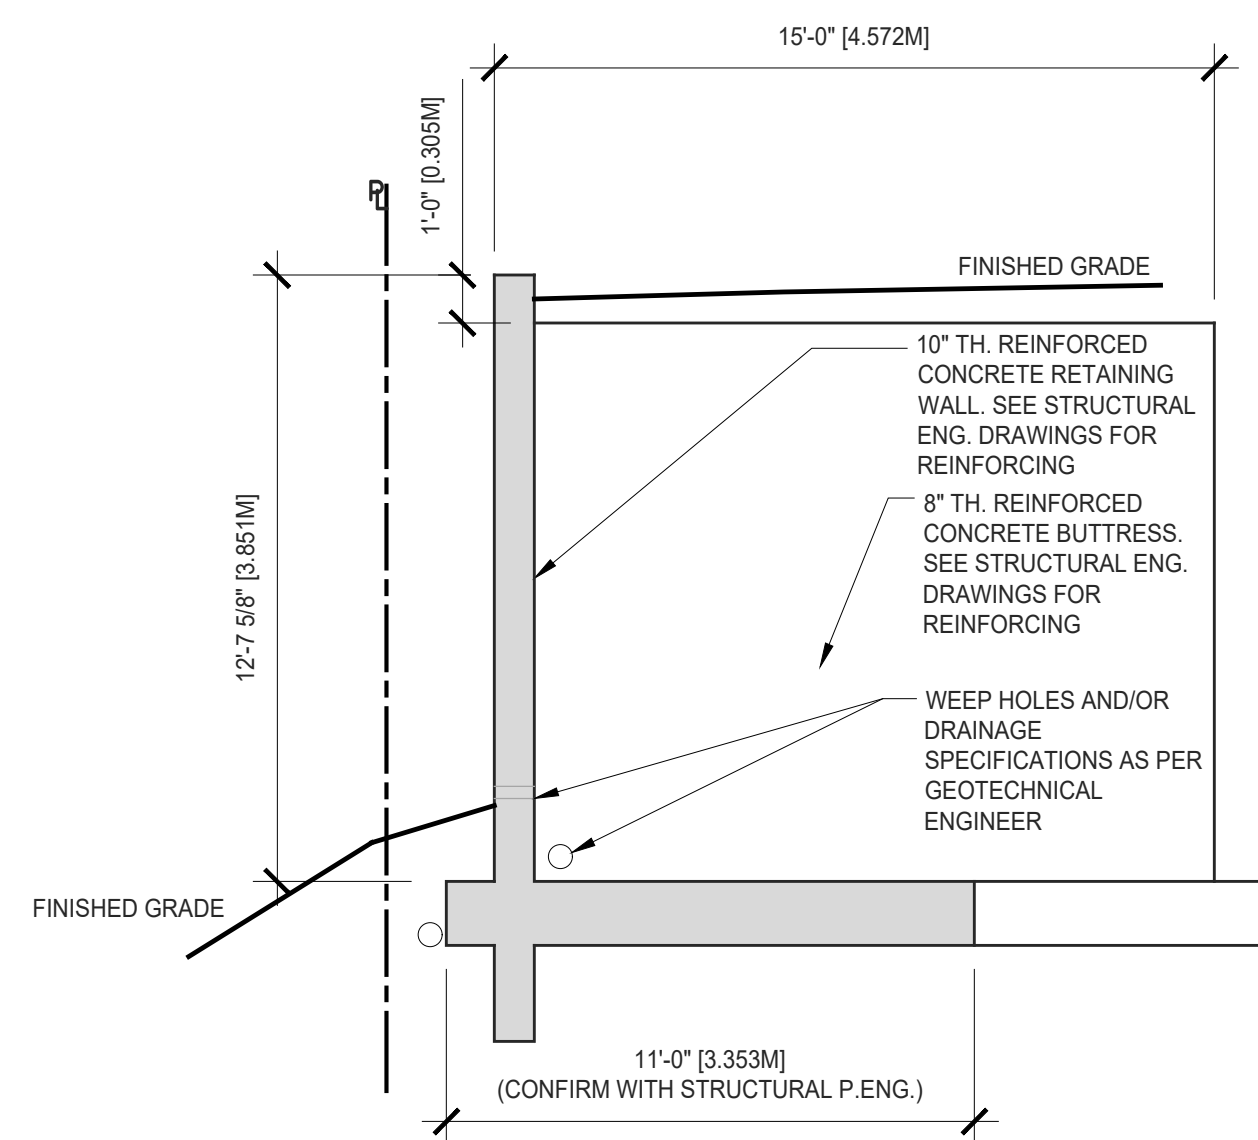
B SECTION AT LOWER BUTTRESS
SCALE: 1/4" = 1'-0"

NOTE: FOR RETAINING WALL THICKNESSES AND STRUCTURAL DETAILS, SEE STRUCTURAL ENG. DRGS.

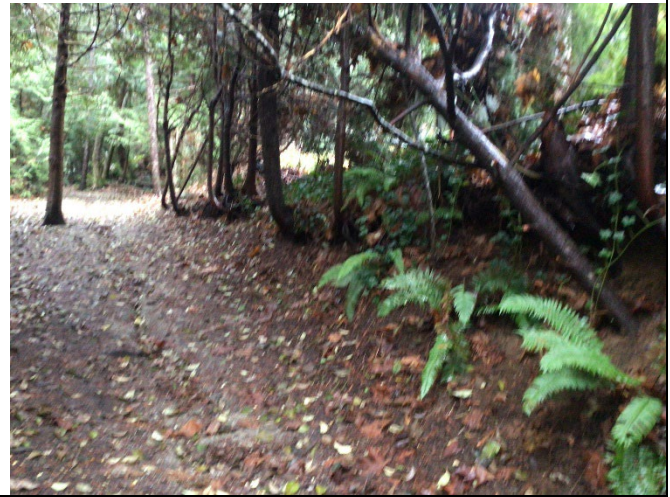
Photo 2. Viewing east, revegetation area along retaining wall, note established plant cover.

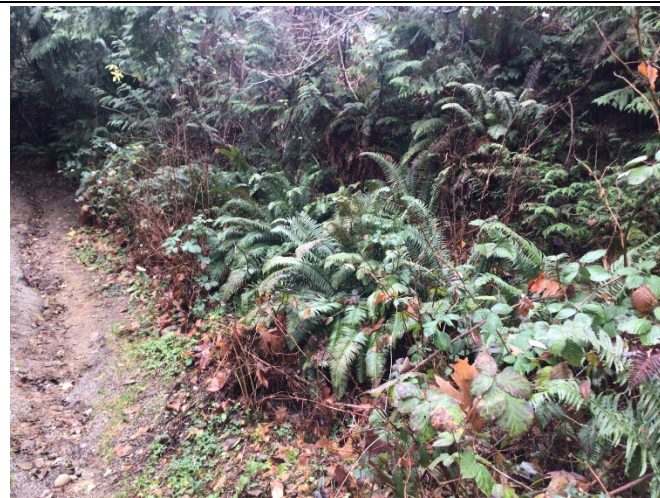
Photo 3. Viewing east, revegetation area along retaining wall, note established plant cover.

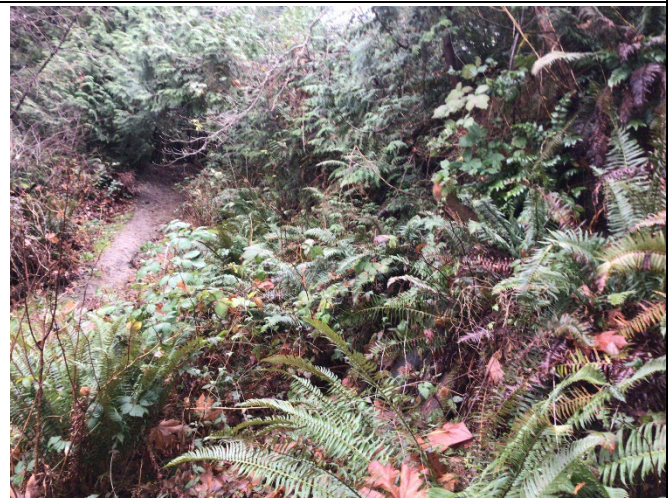
Photo 4. Viewing east, revegetation area along retaining wall near ocean setback and western extent of retaining wall.
