DEVELOPMENT PERMIT NO. 2022 – 25

Addressed as: 5750 Anchor Road

Re: GEOTECHNICAL HAZARD ASSESSMENT – MULTI-FAMILY RESIDENTIAL STRUCTURE 5750 Anchor Road, Sechelt, BC

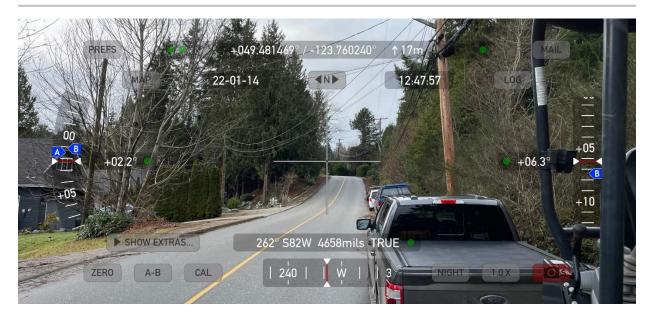
Photograph 1: Showing site access conditions to the west of site.

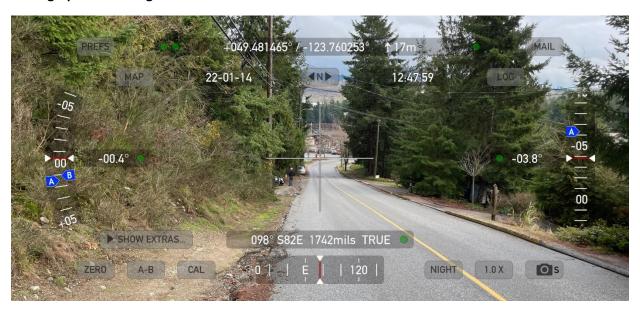
Photograph 2: Showing site access conditions to the east of site.

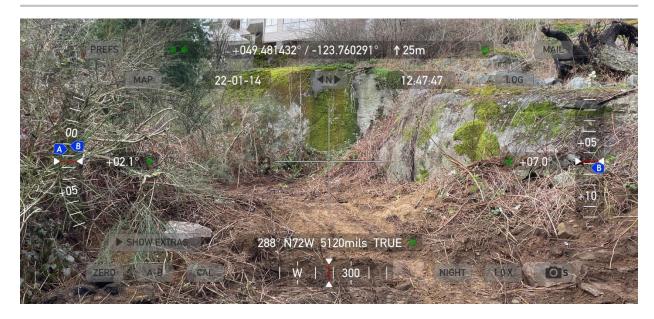
Photograph 3: Showing the bedrock surface near the base of the first planned unit.

The first unit of the proposed development will be placed near the centre of the site on a lower bedrock bench. To prepare for construction, the rock surface in the area should be cleared of overburden soil and pressure washed to expose the rock surface. The rock surface must be reviewed by a qualified geotechnical professional to ensure that the discontinuities in the rock surface don't provide localized conditions of rock instability below or above the development. The qualified professional must review the footing locations to ensure intactness of the rock surface. Further recommendations on preparing footing areas is provided in Foundation Design in this report.

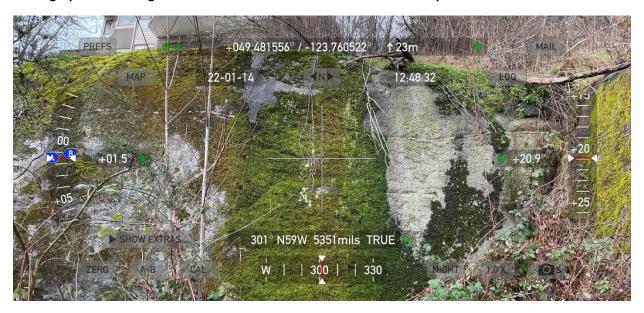
Photograph 4: Showing the intact rock slope above the base of the first unit.

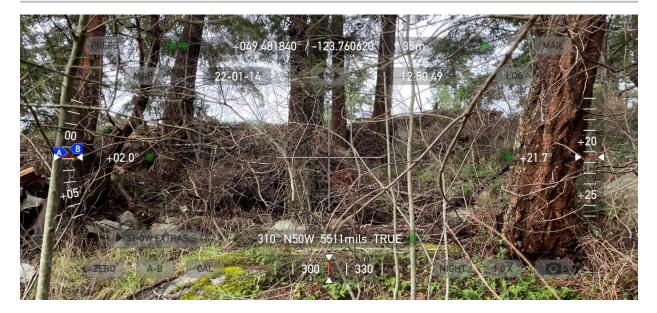
Photograph 5: Showing the next bedrock bench above the first planned unit.

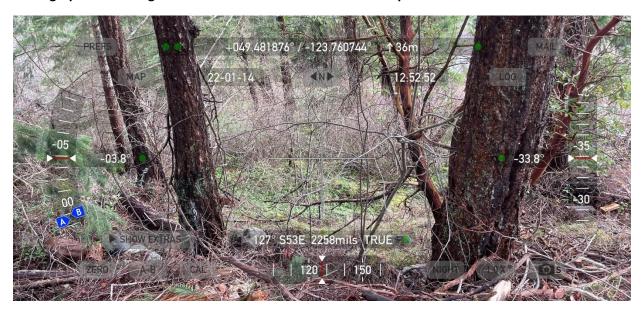
Photograph 6: Showing the downslope perspective of the area shown in Photograph 5.

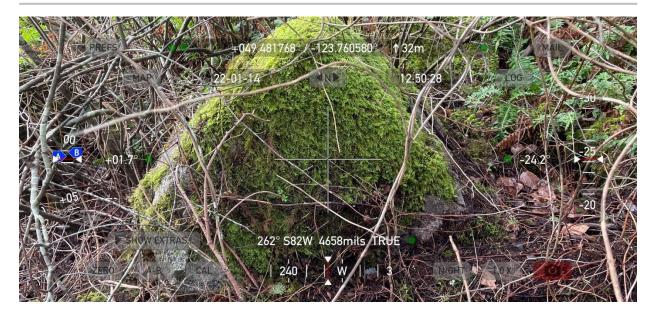
Photograph 7: Showing overgrown talus particle on the eastern extent of site.

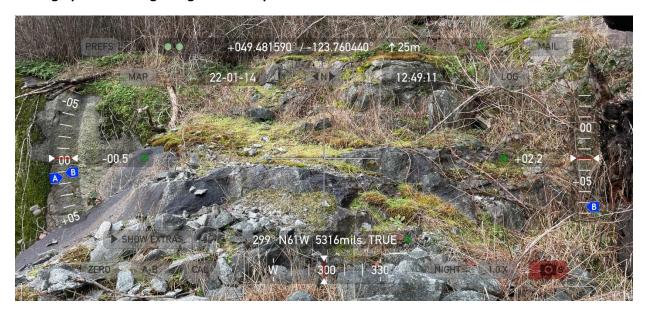
Photograph 8: Showing talus on the eastern extent of site.

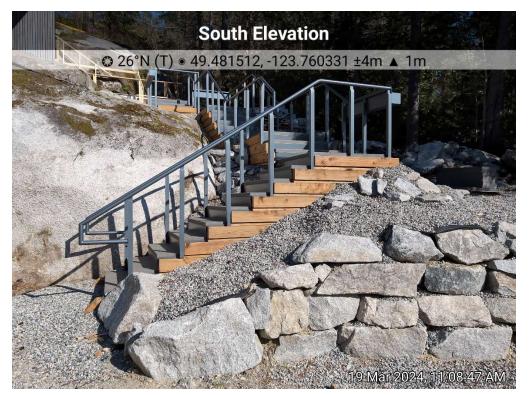
Photograph 1 - Showing western portion of the wall.

The retaining wall is made of large boulders and placed with a negative batter up to a height less than 1.2 m in height. The construction is appropriate for this size and application. It is concluded that it is stable and unlikely to fail. However, in the improbable scenario of a failure, the collapse of this wall would not result in damage to the dwelling or neighboring properties.

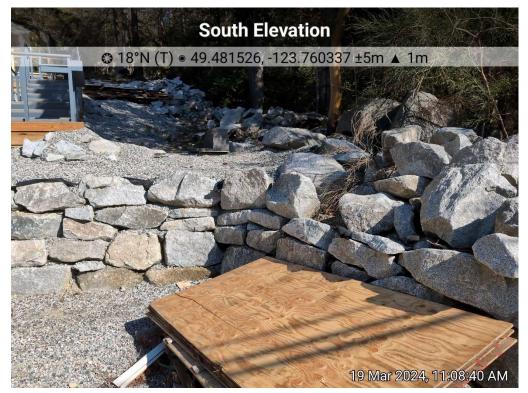
Photograph 2 - Showing eastern portion of the wall.
